# Typical Glazing Bar Details

## HG57 MEDIUM Bar

# HG Thermally Broken Roof Vent Vent Assembly

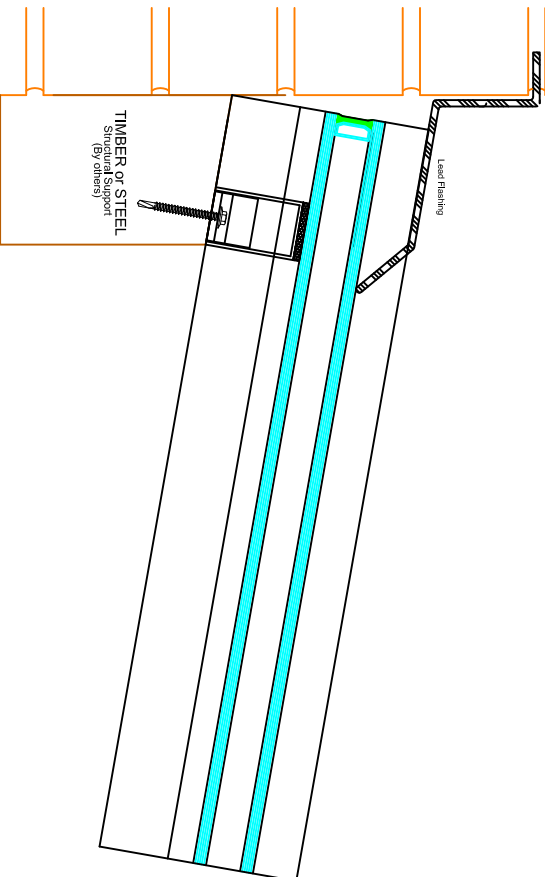
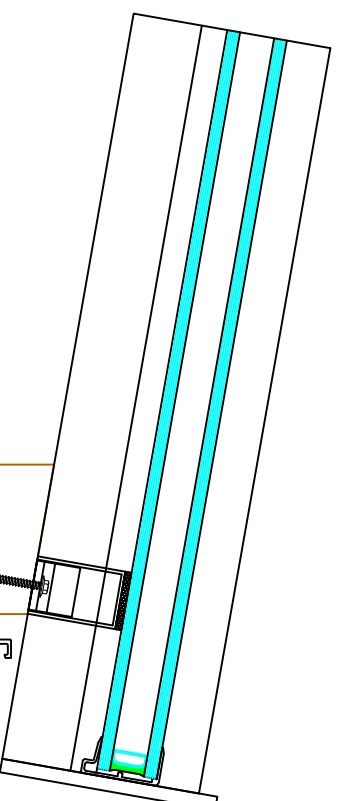
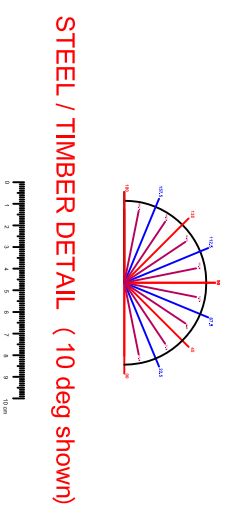
## HG57 MEDIUM BAR

# Typical Glazing Bar Details

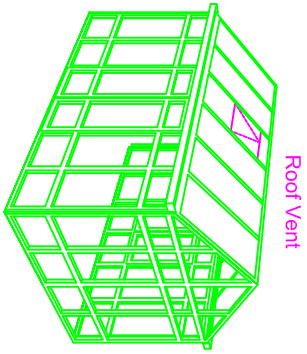
# Typical Roof Vent

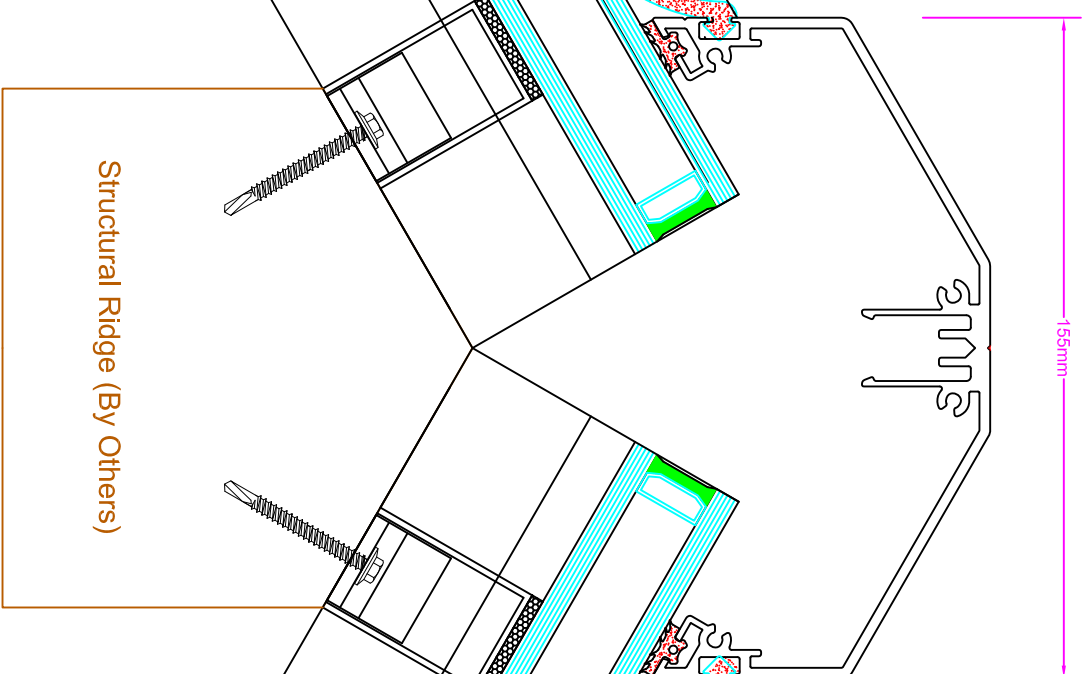
# Typical Ridge Detail

## HG Thermally Broken Roof Vent Ridge Assembly

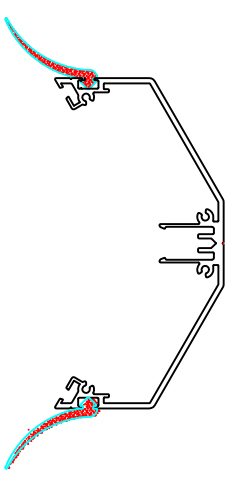
Aluminium Ridge Outer Capping

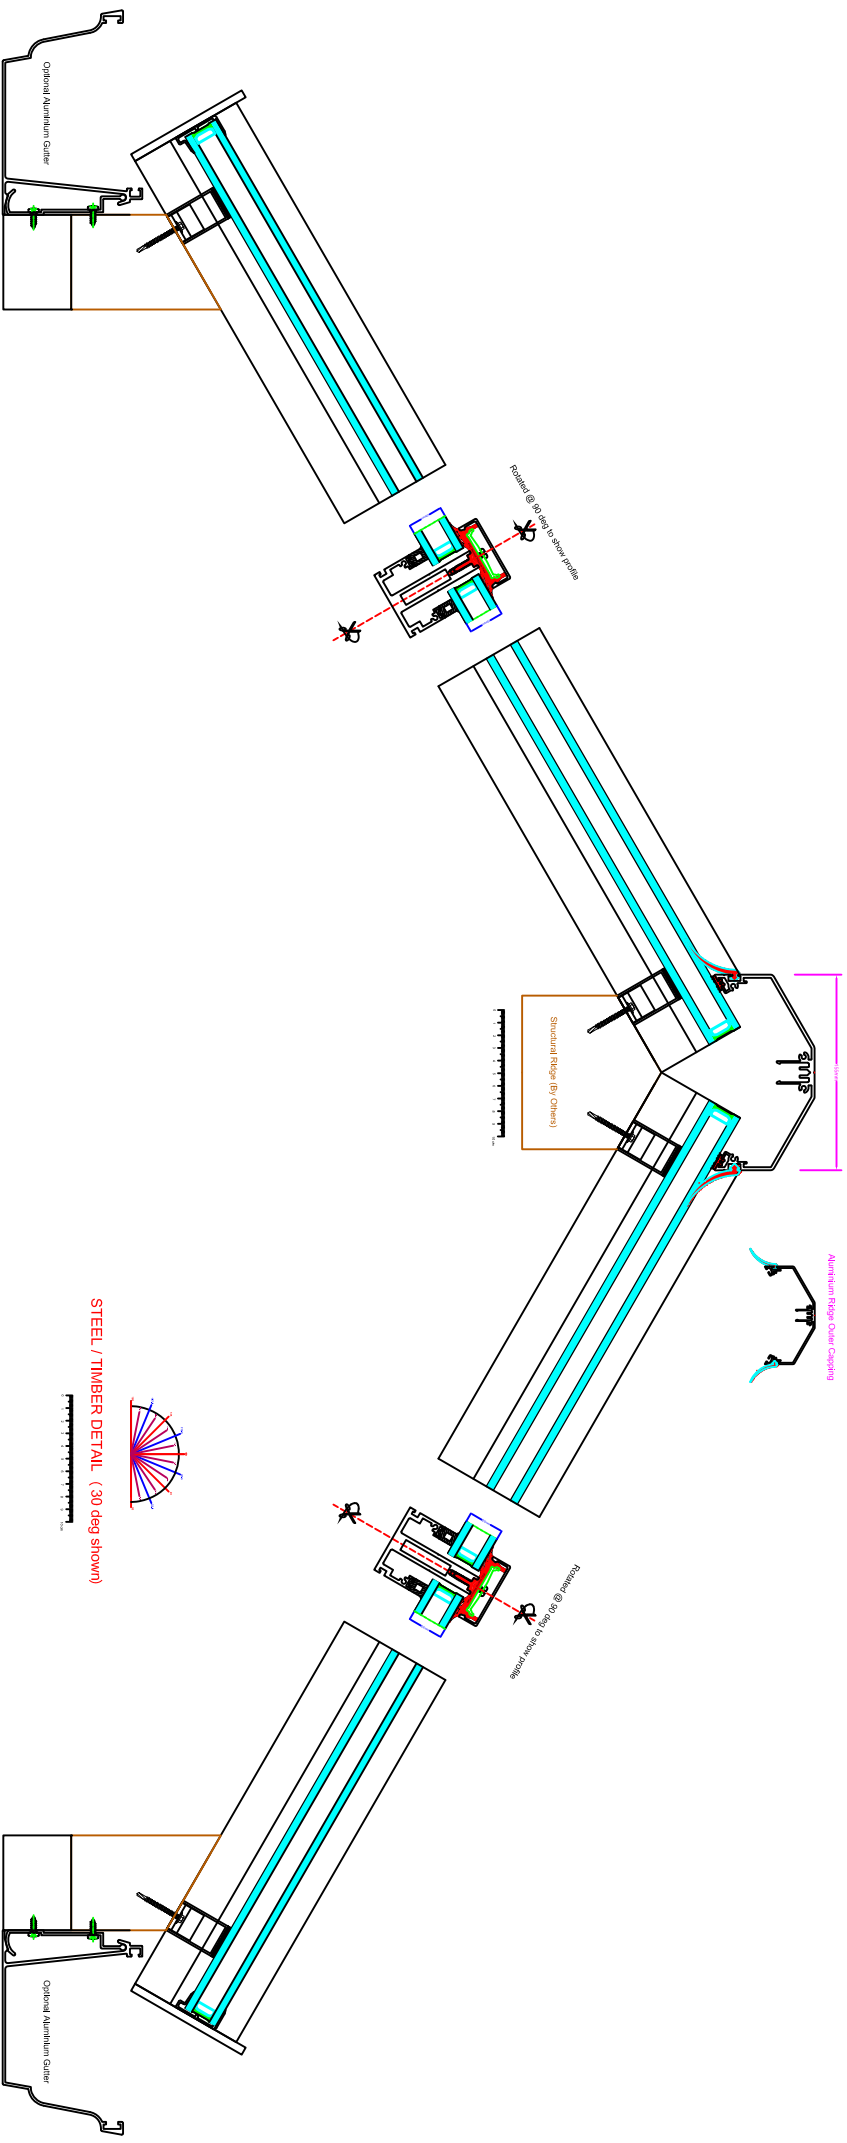
# Typical Ridge Detail

# HG Thermally Broken Roof Vent Ridge Assembly
